Report No. DOT/FAA/PM-85/30

Project Report  
ATC-136

# Pilot Evaluation of TCAS in the Long Ranger Helicopter

J.W. Andrews

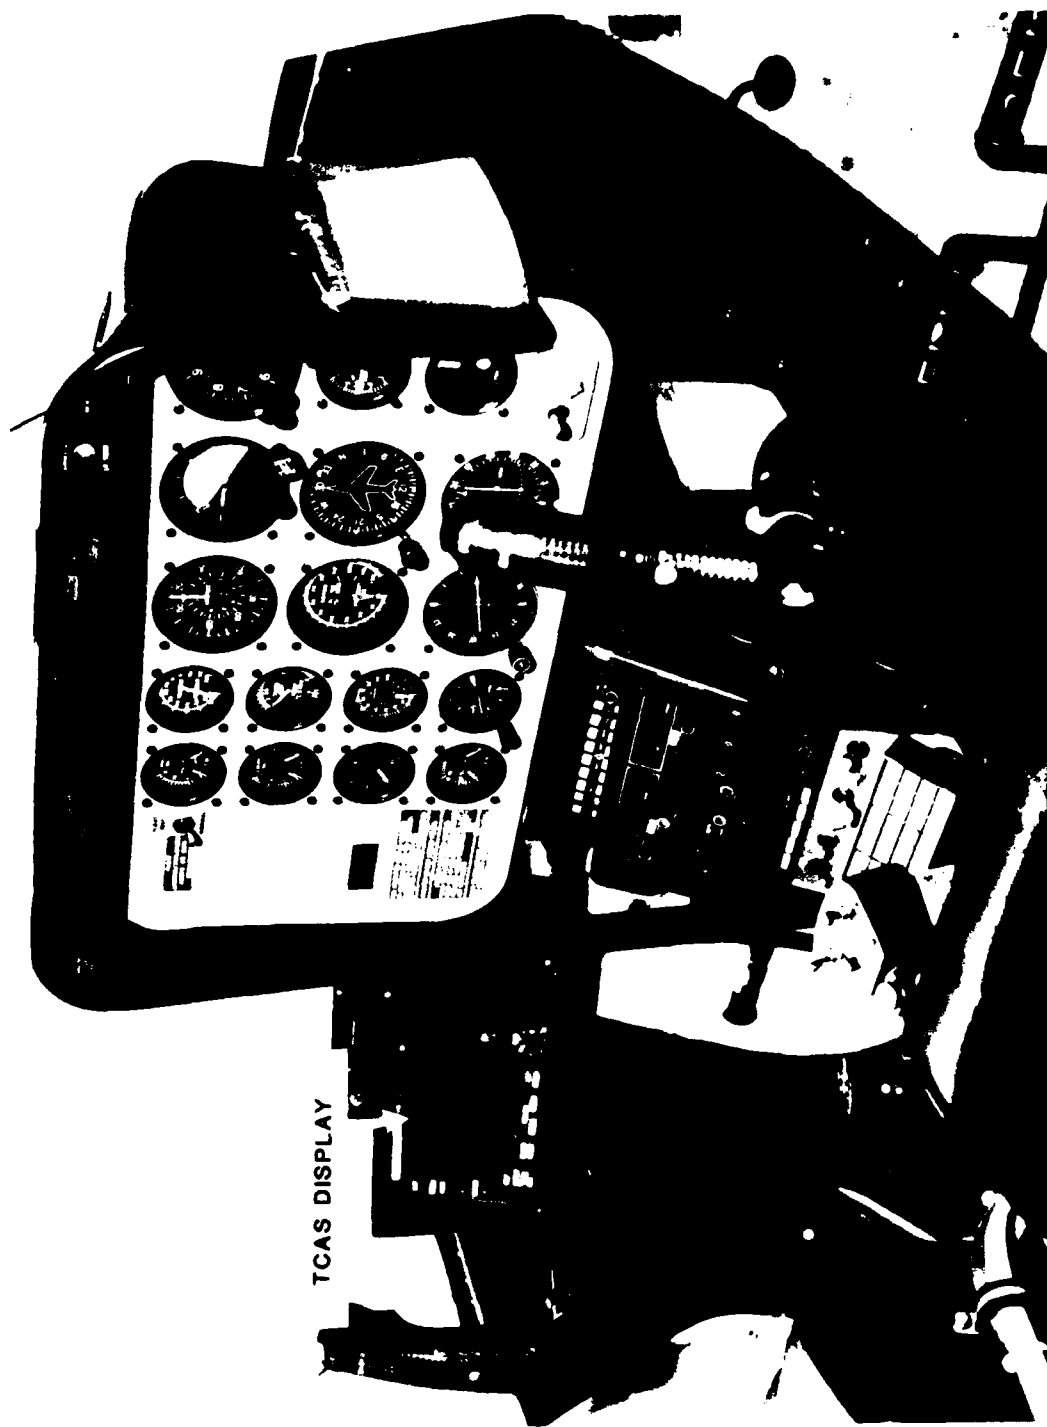
Fig. 1.2 TCAS display installed in the Long Ranger cockpit.

Figure 1.2 shows the TCAS traffic advisory display mounted in the Long Ranger cockpit. The display consisted of a Bendix IN-2027A color weather radar indicator operated as part of a special display unit known as the Airborne Intelligent Display (AID). This display unit was built at Lincoln Laboratory and used previously in TCAS testing in a Cessna 421 fixed-wing aircraft. The dimensions of the face of the indicator were 4.25 inches by 3.25 inches. The resolution was 256 pixels by 256 pixels. Alphanumeric characters were a maximum of 5 pixels in width and 14 pixels in height (approximately 0.08 by 0.17 inches). The display was mounted on a special bracket installed in the left-hand side of the cockpit. In an actual rotorcraft installation, it is likely that a lightweight, monochrome display would be employed and that it would be mounted on the center console. However, the information content of the AID display was identical to that anticipated for actual rotorcraft implementations and display characteristics peculiar to the experimental installation are not thought to have had any significant influence on test results.

The location of the display in the far left side of the cockpit was a known artificiality of the test installation and hence was not commented upon by the subjects.
